**REQUEST FOR PROPOSAL
MIDWESTERN STATE UNIVERSITY
PURCHASING & CONTRACT MANAGEMENT DEPARTMENT
3410 Taft Blvd., Daniel Bldg., Rm. 202
Wichita Falls, TX. 76308**

735-16-8165

**Exterior Window Painting Hardin
Building**

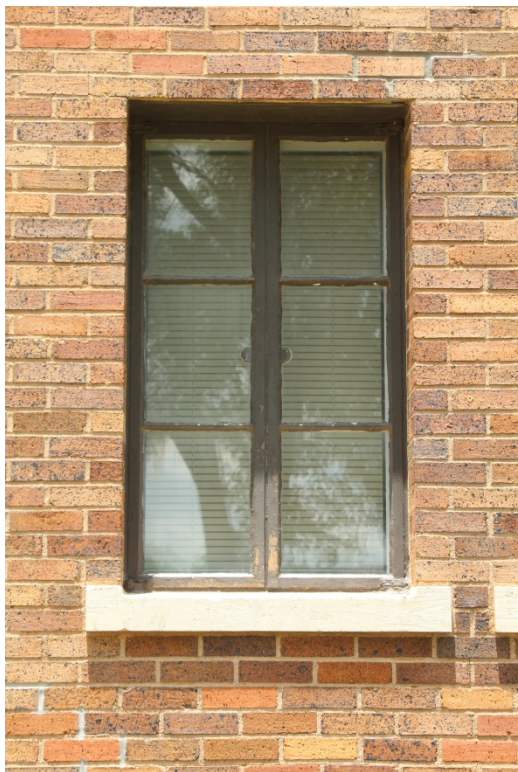
Type A Windows, ~55" x 32 ½", from south Hardin, first floor

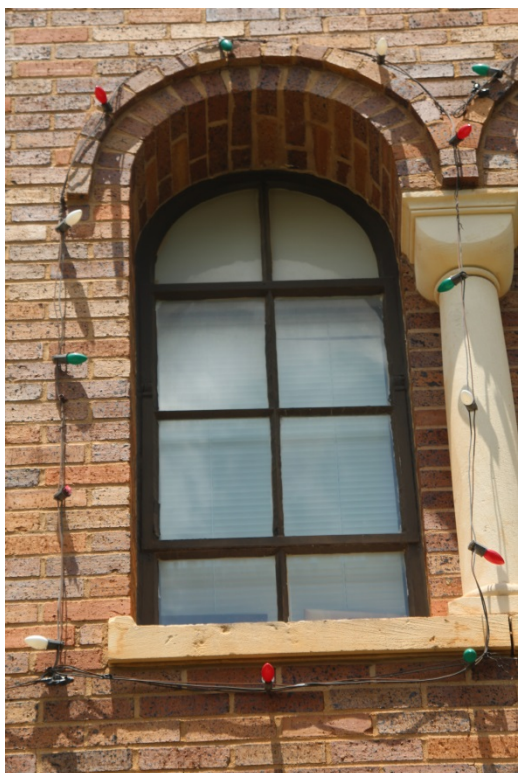
Type B Windows, ~72" x 20", from south Hardin, second floor

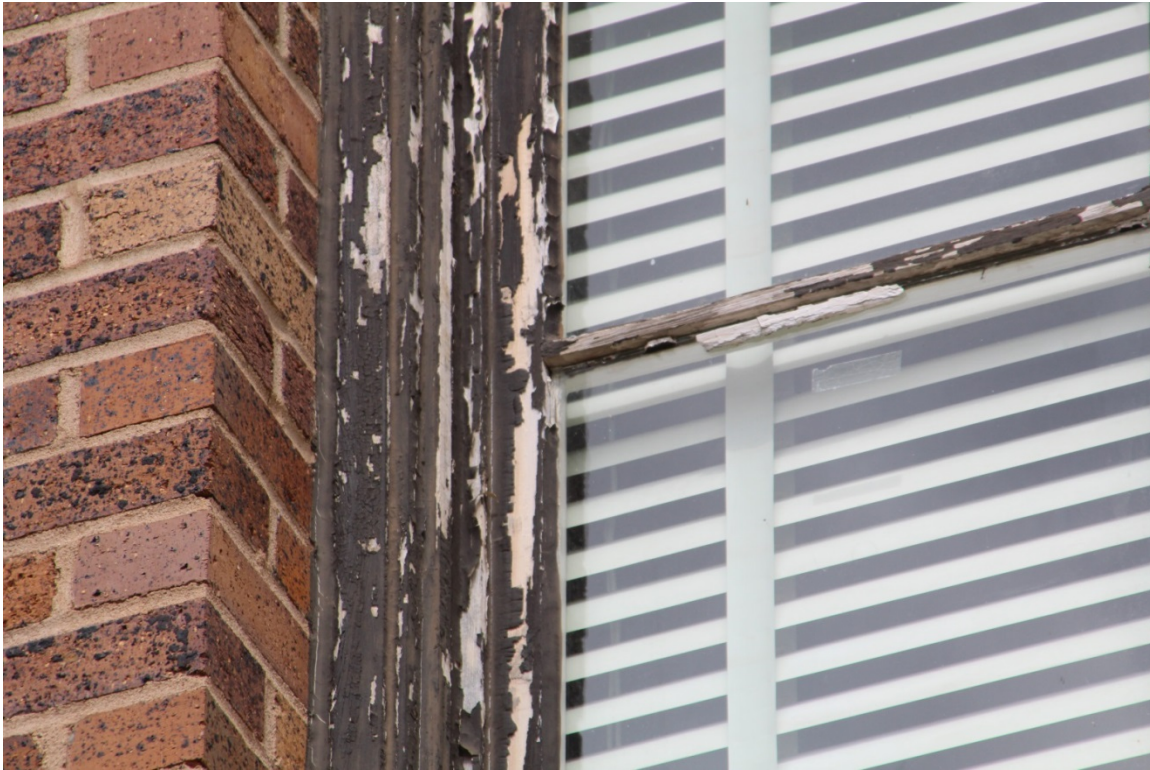
Close up of second floor windows, Hardin

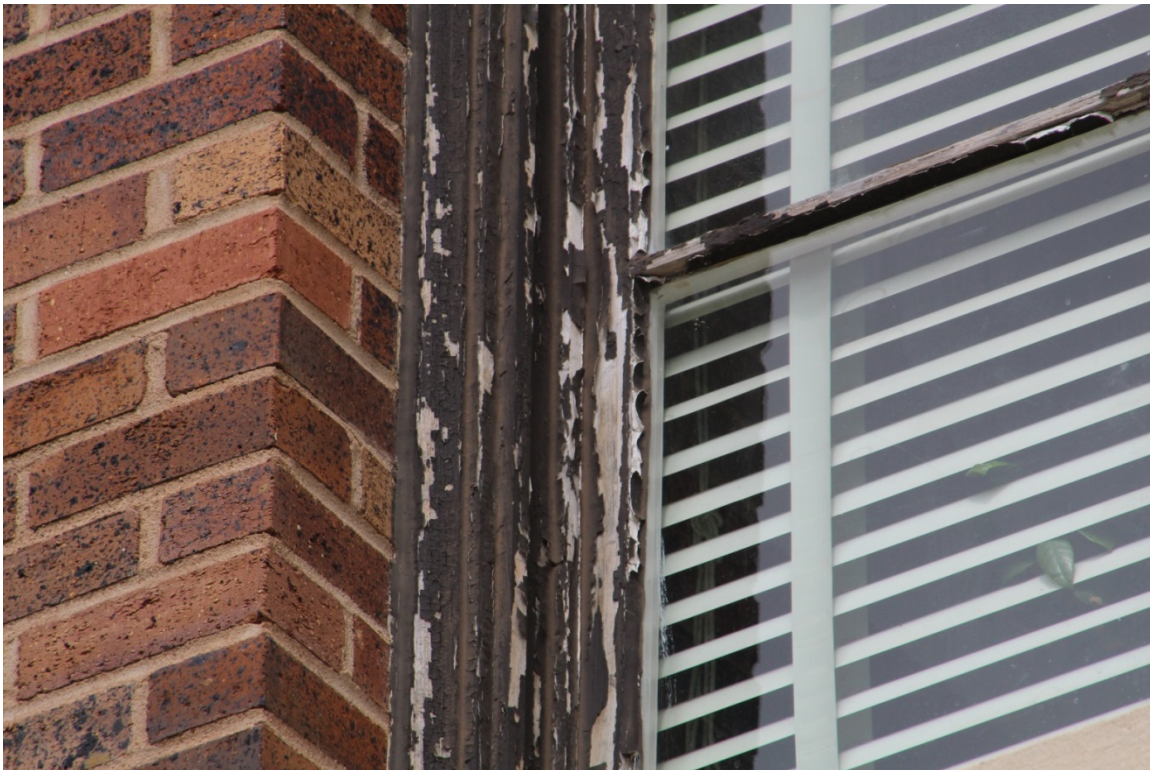
Close up of second floor windows, Hardin

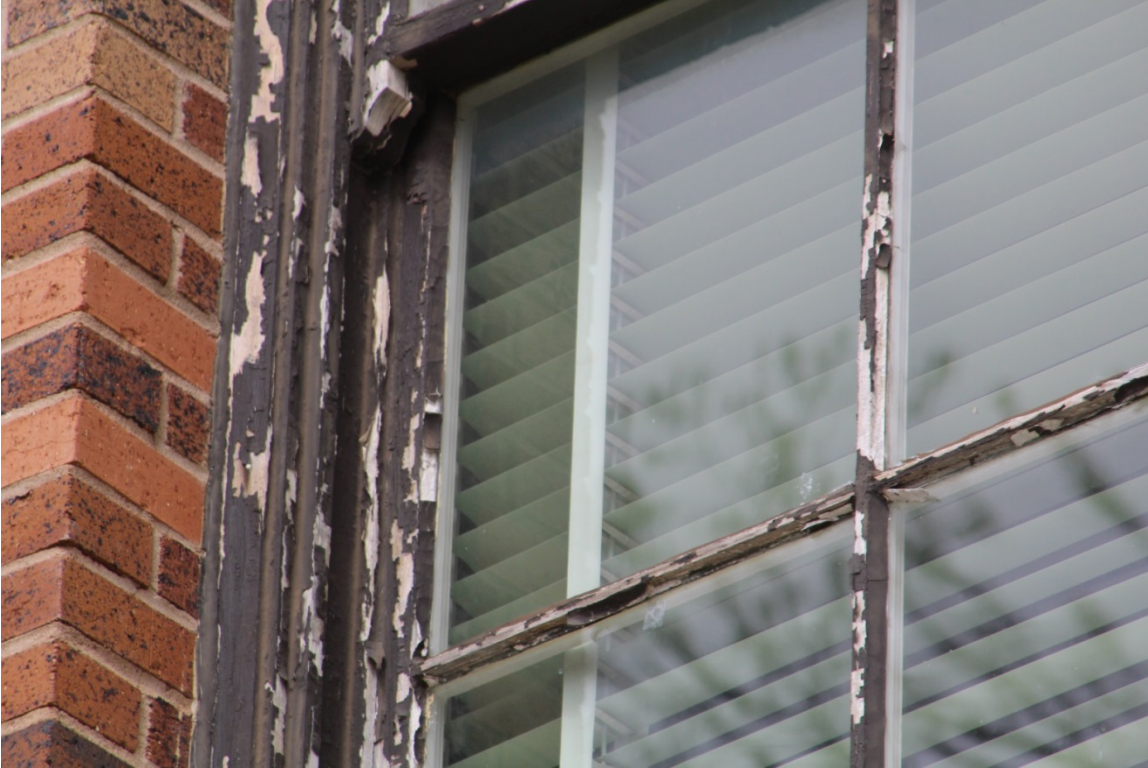
Close up of second floor windows, Hardin

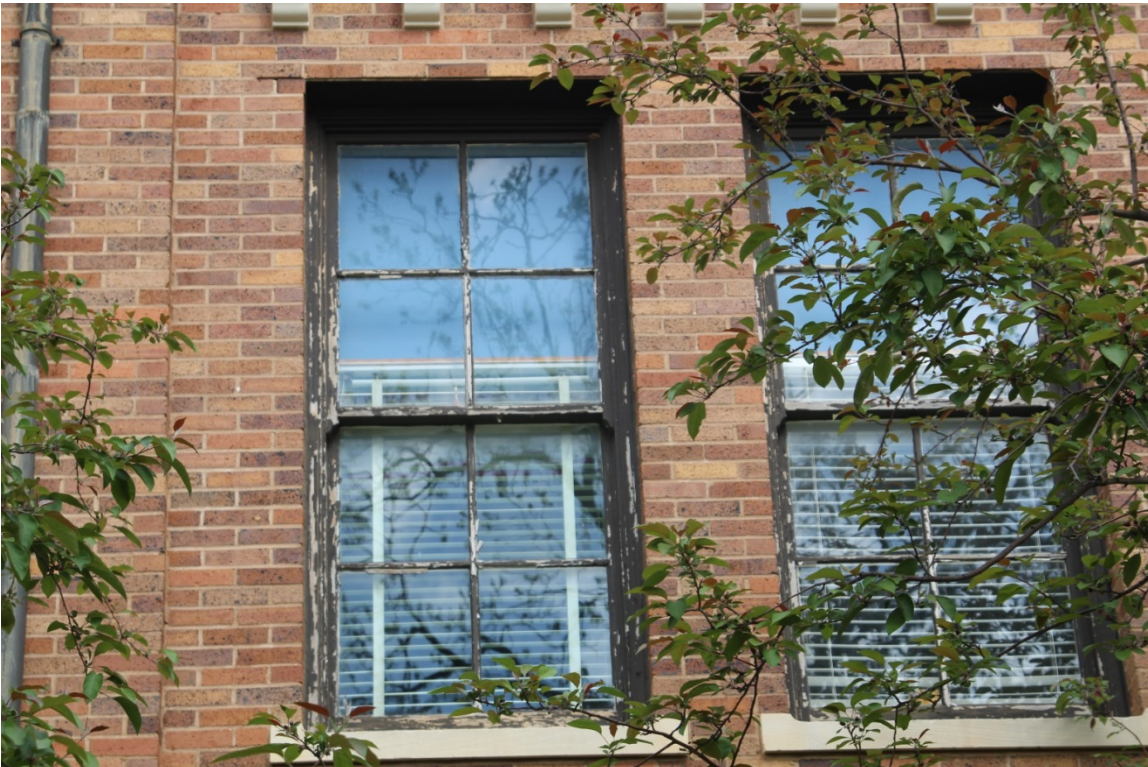
Second floor windows, Hardin

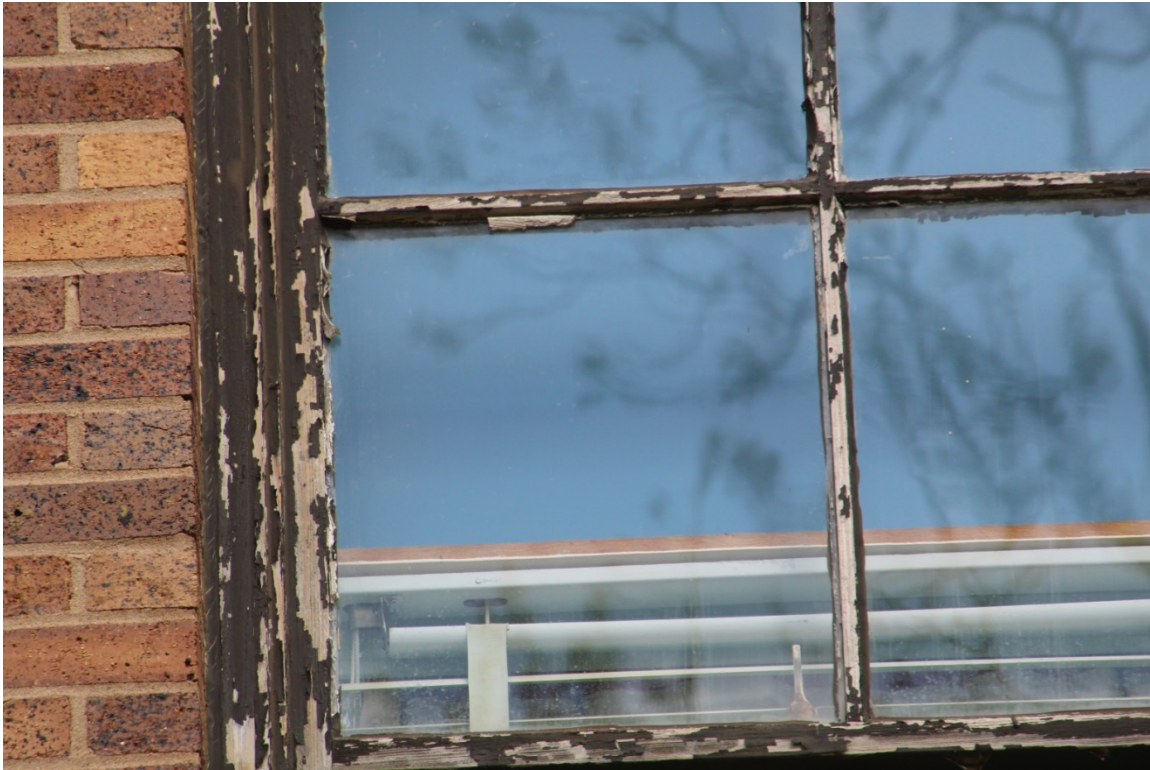
Close up of second floor windows, Hardin

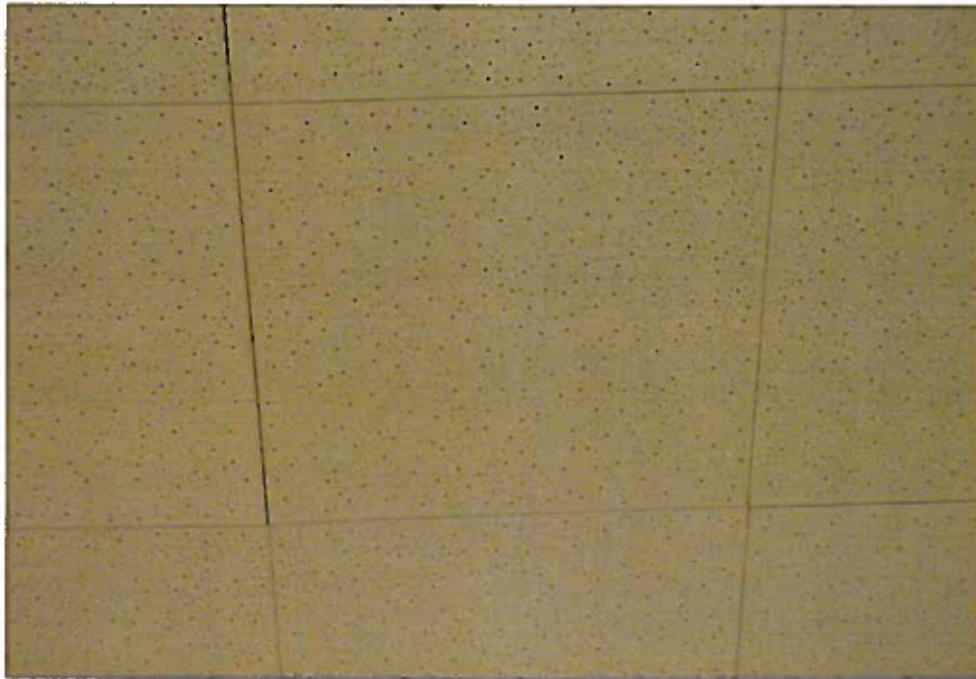
Ceiling Tile	5	-	221	-	Friable	Hazard Rank: 2
Homog. Area Description:	12"x12" Ceiling tiles, white w/ random dot patterns.					
Amount of Material:	~13,300sf					
Homog. Area Definition:	This material can be found in the classrooms, hallways, and offices.					
Functional Space:	Public Area					
Sample Location:	Collected in main hall near the south stairs, at the center of the hall, At damage site.2-3-F.					
Primary Analysis Results:	<u>Amosite</u>				2%	
Secondary Analysis Results::	<u>No Asbestos Detect</u>				0%	
Tan fibrous ceiling tile.

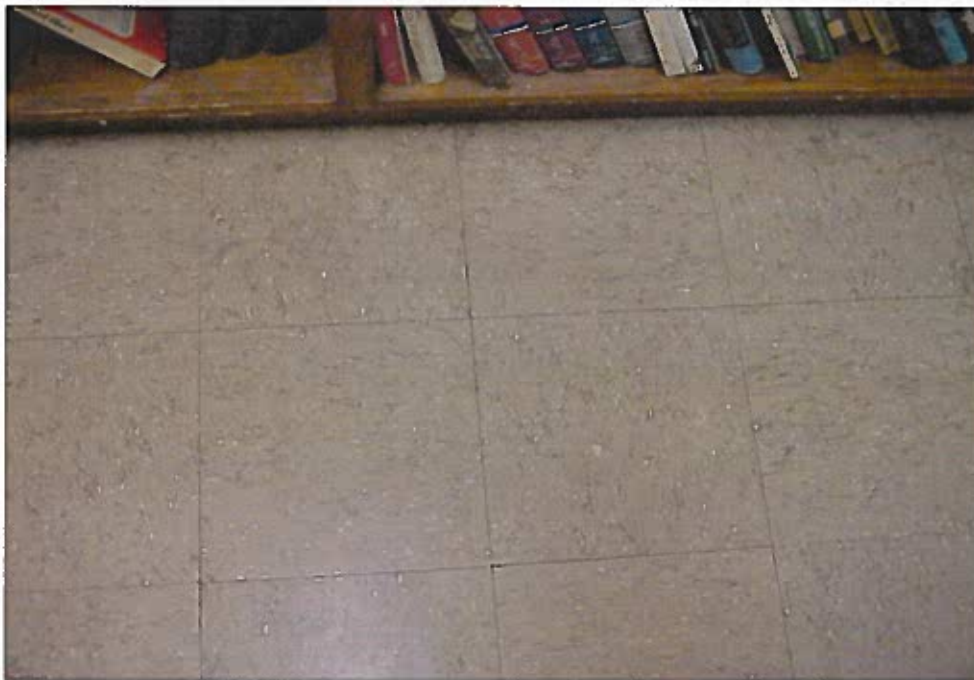
Floor Tile	13	-	202	-	Non-Friable	Hazard Rank: 1
Homog. Area Description:	12"X12" Floor tile brown w/ flecks.					
Amount of Material:	~22,900sf					
Homog. Area Definition:	This material can be found throughout the entire building.					
Functional Space:	Public Area					
Sample Location:	Collected from outside of room 229 at the corner, 2-3-F.					
Primary Analysis Results:	<u>Chrysotile</u> 2%					
Secondary Analysis Results::	0%

Tan floor tile.

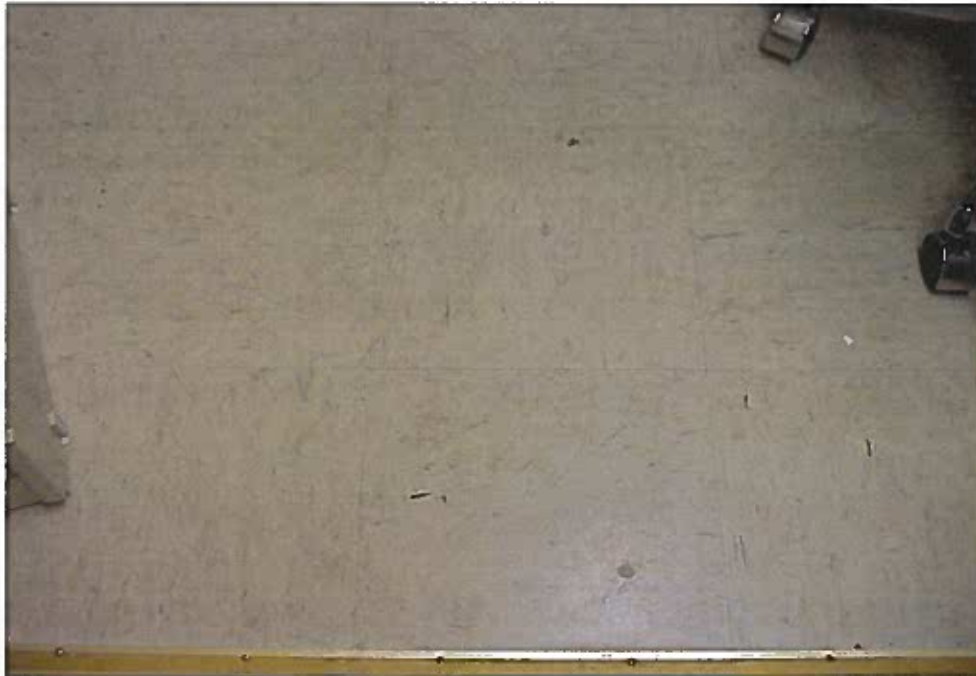
Floor Tile	14	-	205	-	Non-Friable	Hazard Rank: 1
Homog. Area Description:	12"x12" Floor tile, white w/ flecks.					
Amount of Material:	~80sf					
Homog. Area Definition:	This material is in the vault room, or room 103-C.					
Functional Space:	Public Area					
Sample Location:	Collected from room 103-C, vault, 1-F.					
Primary Analysis Results:	<u>Chrysotile</u> 5%					
Secondary Analysis Results:	<u>No Asbestos Detect</u> 0%					
No asbestos detected in second layer mastic.

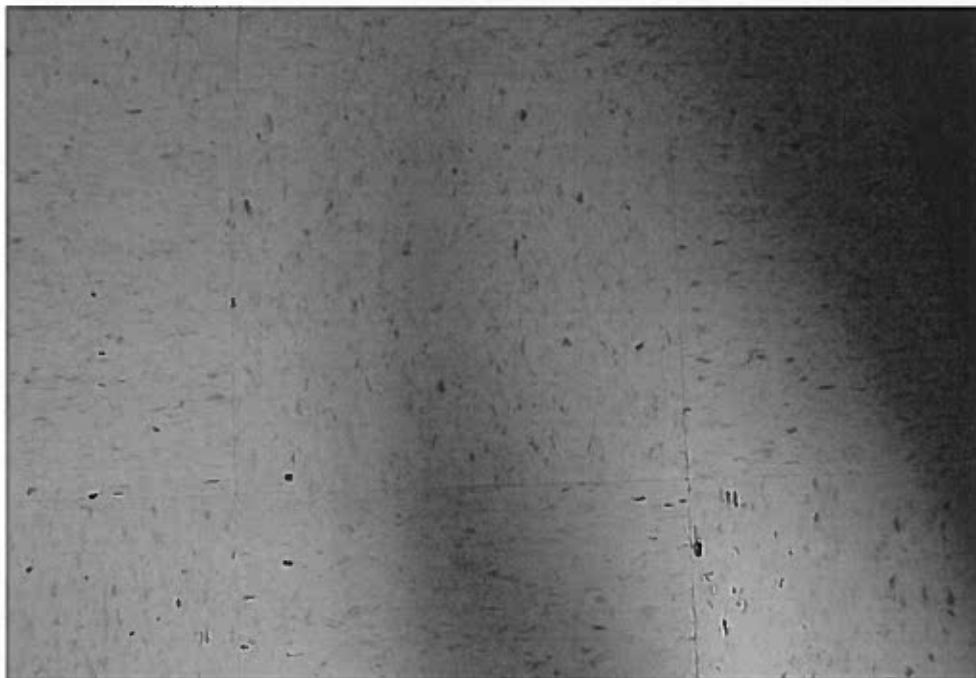
Floor Tile	15	-	261	-	Non-Friable	Hazard Rank: 1
Homog. Area Description:	12"x12" floor tile, white w/ gray flecks.					
Amount of Material:	~120sf					
Homog. Area Definition:	Materials found in room 112- the file room, offices, & copy room.					
Functional Space:	Public Area					
Sample Location:	Collected from the copy room at wall 3.					
Primary Analysis Results:	<u>Chrysotile</u> 4%					
Secondary Analysis Results::	<u>No Asbestos Detect</u> 0%					
4% chrysotile was discovered in second layer mastic.

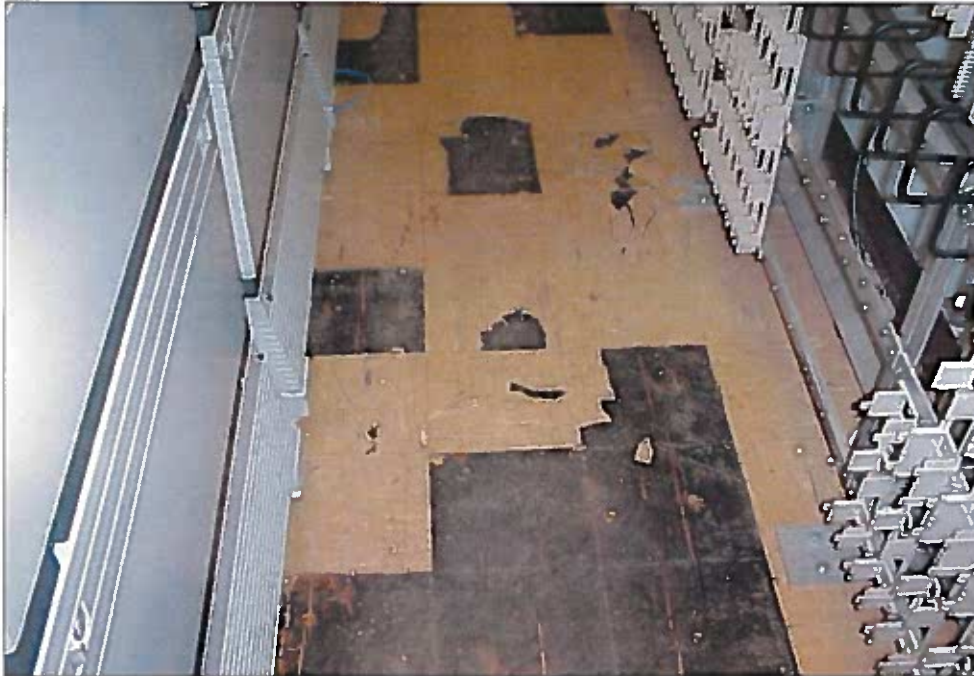
Floor Tile	16	-	287	-	Friable	Hazard Rank: 4
Homog. Area Description:	9" x 9" floor tile, brown w/ black mastic.					
Amount of Material:	~540sf					
Homog. Area Definition:	Materials found in telephone equipment room.					
Functional Space:	Public Area					
Sample Location:	Collected from telephone room in the basement.					
Primary Analysis Results:	<u>Chrysotile</u> 8%					
Secondary Analysis Results::	<u>No Asbestos Detect</u> 0%					
Light brown floor tile.

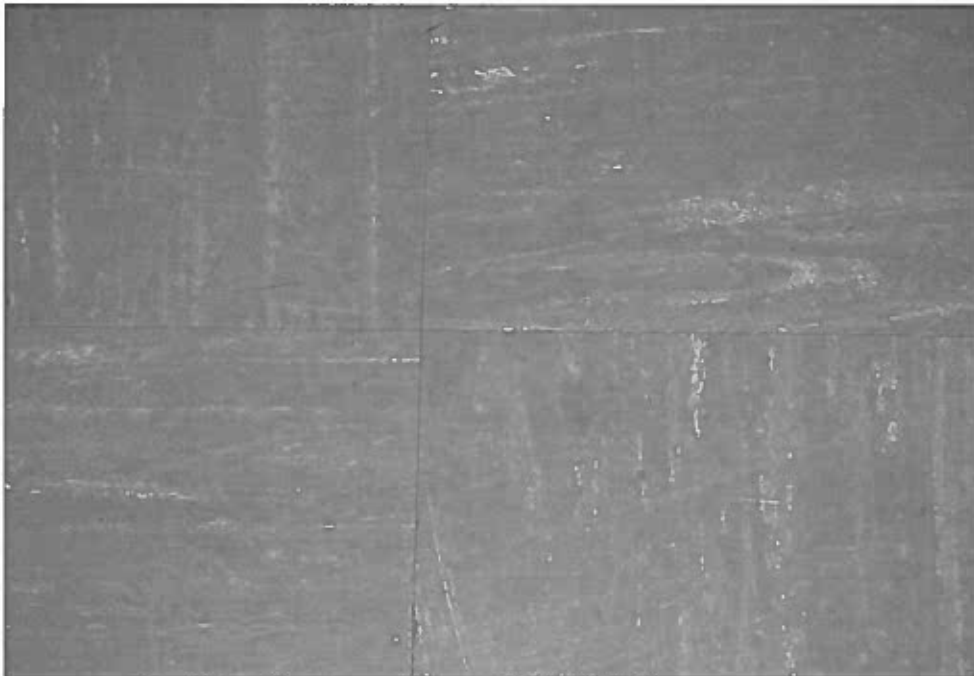
Floor Tile	17	-	308	-	Non-Friable	Hazard Rank: 3
Homog. Area Description:	Green floor tile					
Amount of Material:	~300sf					
Homog. Area Definition:	In the women's restroom , 1st floor					
Functional Space:	Public Area					
Sample Location:	Collected from women's bathroom on the first floor					
Primary Analysis Results:	<u>Chrysotile</u>		3%			
Secondary Analysis Results::	<u>Chrysotile</u>		2%

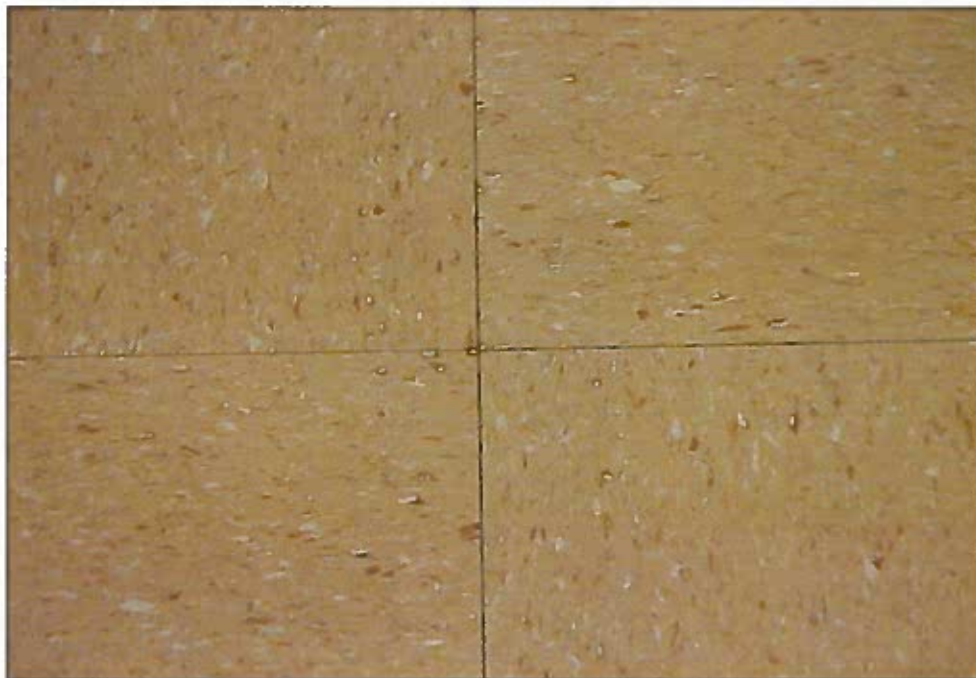
Floor Tile	18	-	312	-	Non-Friable	Hazard Rank: 2
Homog. Area Description:	Floor tile					
Amount of Material:	~25sf					
Homog. Area Definition:	Salient area located in the women's bathroom on the first floor					
Functional Space:	Public Area					
Sample Location:	Collected from women's bathroom					
Primary Analysis Results:	<u>Chrysotile</u>		3%			
Secondary Analysis Results::	<u>Chrysotile</u>		5%

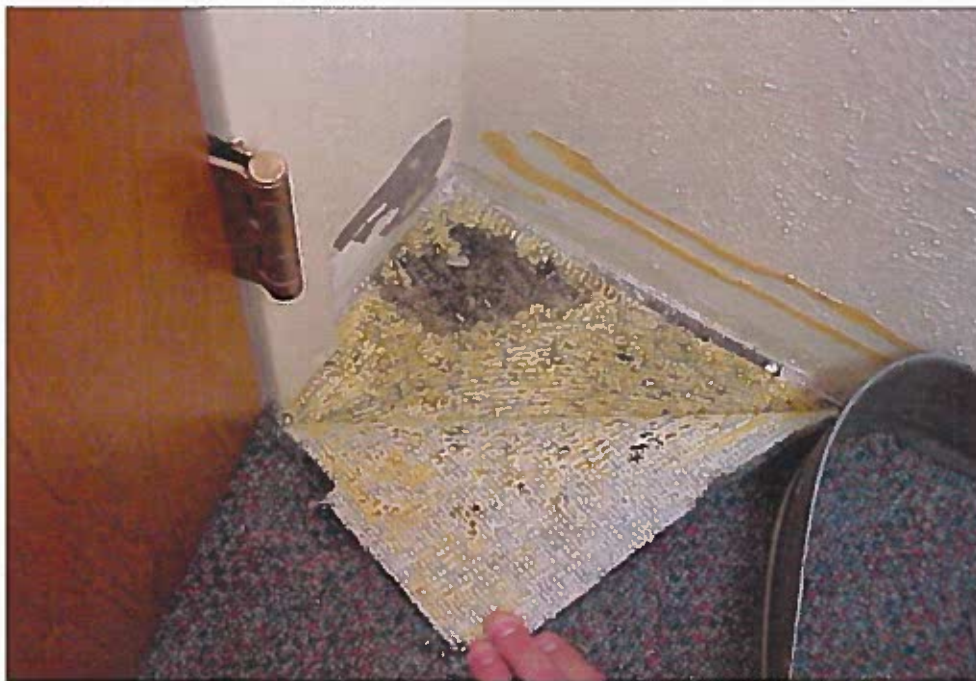
Mastic	6	- 243 -	Non-Friable	Hazard Rank: 1
Homog. Area Description:	Black mastic under carpet.			
Amount of Material:	~474sf			
Homog. Area Definition:	Material was found under the carpet in all areas of the room 202 (Internal Auditor).			
Functional Space:	Public Area			
Sample Location:	Collected from room 202, copy room at the wall 2 behind door, 2-F.			
Primary Analysis Results:	<u>Chrysotile</u>		2%	
Secondary Analysis Results::			0%	
Yellow and black mastics.

The black mastic referred to in this report as area MM-6. Three samples 241, 242, and 243 were taken and all identified positive. This material can be found under the carpet in room 202. There is approximately 474 square feet of this material.

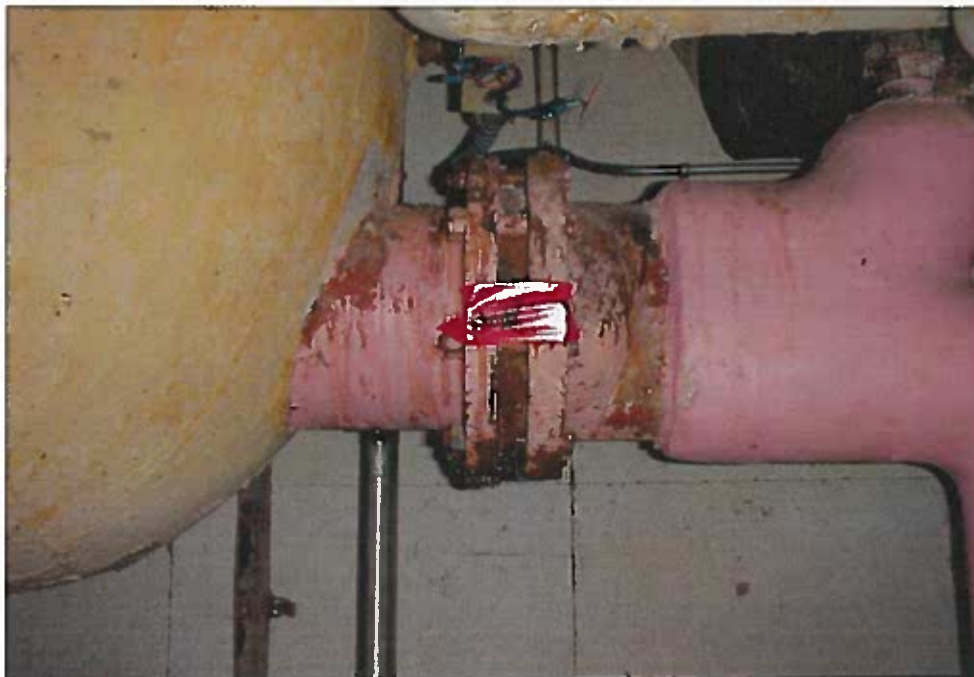
Other 13 - 300 - **Friable** Hazard Rank: 1
Miscellaneous

Homog. Area Description: Gasket material at pipe connections.
Amount of Material: ~30 gaskets
Homog. Area Definition: Material found in mechanical room at pipe connection.
Functional Space: Mechanical
Sample Location: Collected from the mechanical room in the basement.
Primary Analysis Results: Chrysotile 55%
Secondary Analysis Results: 0%

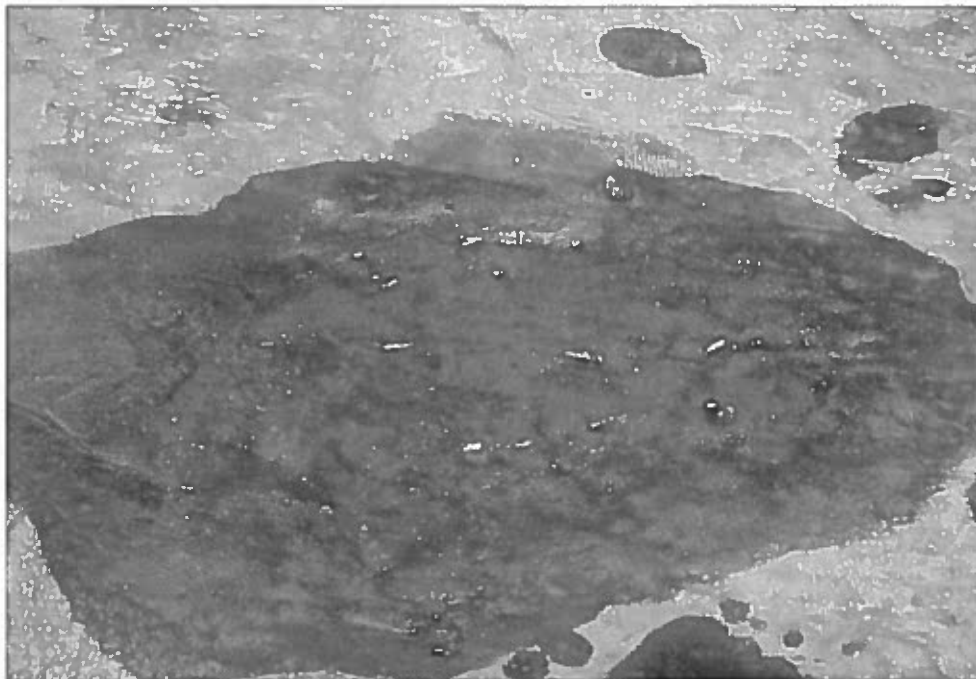
Roofing Material 1	- 171 -	Non-Friable Hazard Rank: 1
Homog. Area Description:	Black Tar and Mastic	
Amount of Material:	~100sf	
Homog. Area Definition:	This material is found in the bell tower.	
Functional Space:	Utility Area	
Sample Location:	Collected from the bell tower floor 2-3-F	
Primary Analysis Results:	<u>Chrysotile</u>	20%
Secondary Analysis Results::		0%
	Black Tar Mastic

The black mastic referred to in this report as area MR-1. Three samples 171, 172, and 173 were taken and all were identified positive. This material can be found on the bell tower floor. There is approximately 100 square feet of this material.

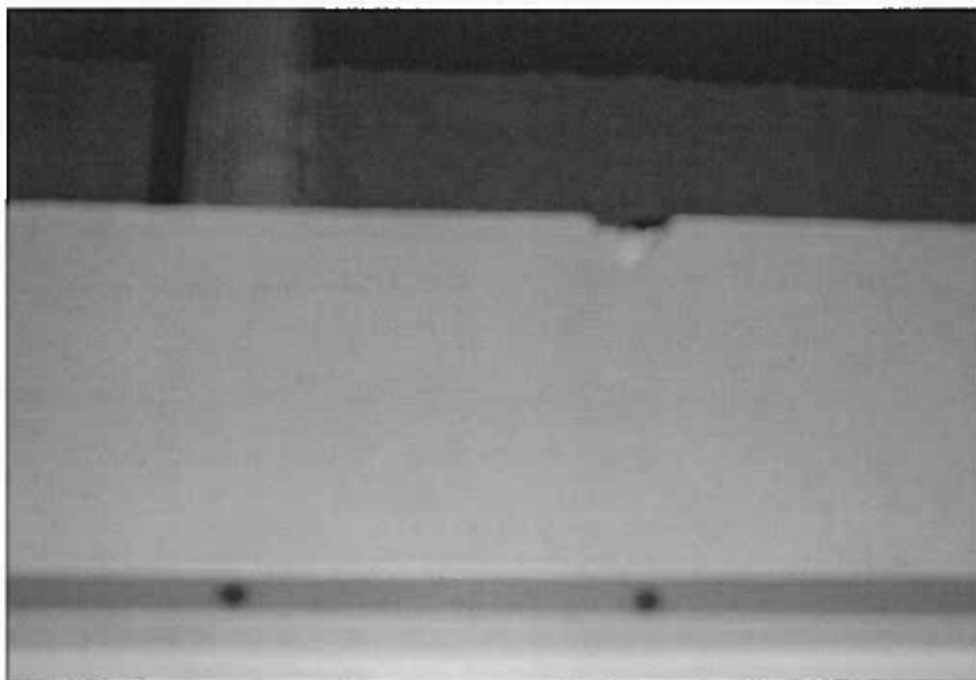
Sheet Rock	8	-	230	-	Friable	Hazard Rank: 1
Homog. Area Description:	Sheet rock w/ joint comp.					
Amount of Material:	~3,380sf					
Homog. Area Definition:	This material can be found on the 2nd floor, remodeled offices on the west side of the building.					
Functional Space:	Public Area					
Sample Location:	Collected from above the ceiling in the hall west at room 222, 2-3-F.					
Primary Analysis Results:	<u>Chrysotile</u> 2%					
Secondary Analysis Results::	0%					
Off-white joint compound.

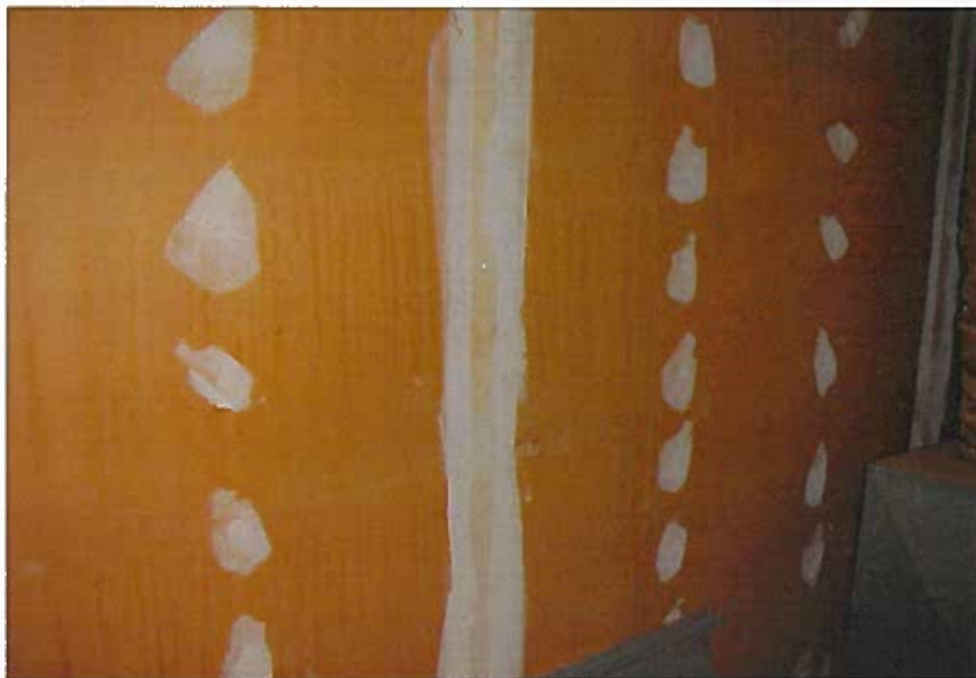
Sheet Rock	11	-	302	-	Friable	Hazard Rank: 1
Homog. Area Description:	Sheet rock with tape and joint compound.					
Amount of Material:	~1,088sf					
Homog. Area Definition:	Material found in telephone equipment room in the basement.					
Functional Space:	Public Area/Mechanical spaces					
Sample Location:	Collected from the center of wall three.					
Primary Analysis Results:	<u>Chrysotile</u> 2%					
Secondary Analysis Results::	<u>No Asbestos Detect</u> 0%					
Off-white joint compound.

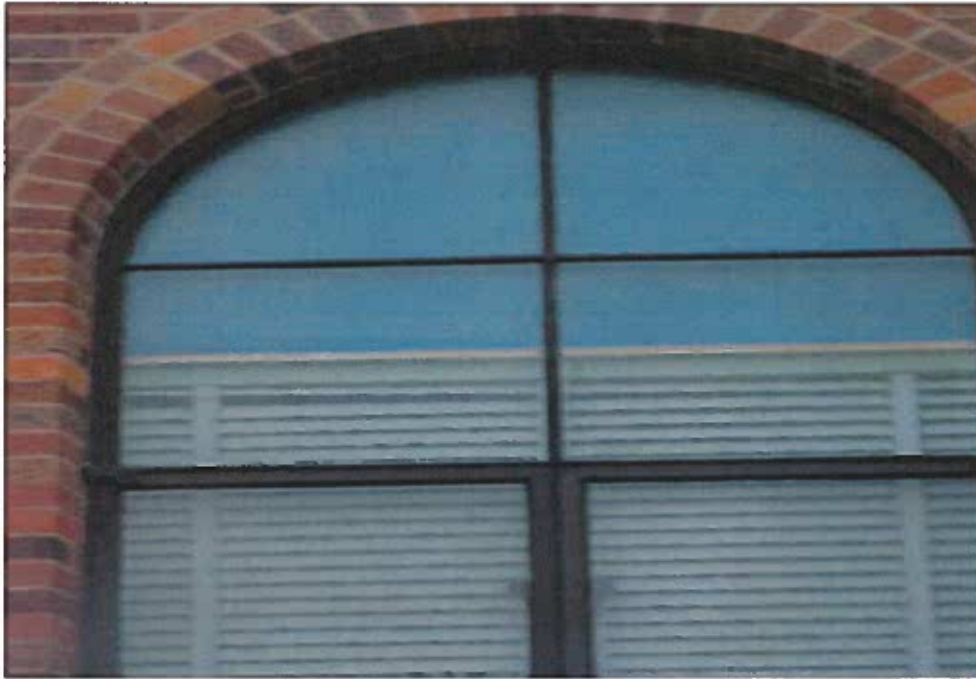
Transite	1	-	304	-	Non-Friable	Hazard Rank: 3
Homog. Area Description:	Transite board					
Amount of Material:	~180sf					
Homog. Area Definition:	Materials found in the windows					
Functional Space:	Public Area					
Sample Location:	Room #216, 2nd window from the left, above ceiling					
Primary Analysis Results:	<u>Chrysotile</u> 20%					
Secondary Analysis Results:	0%

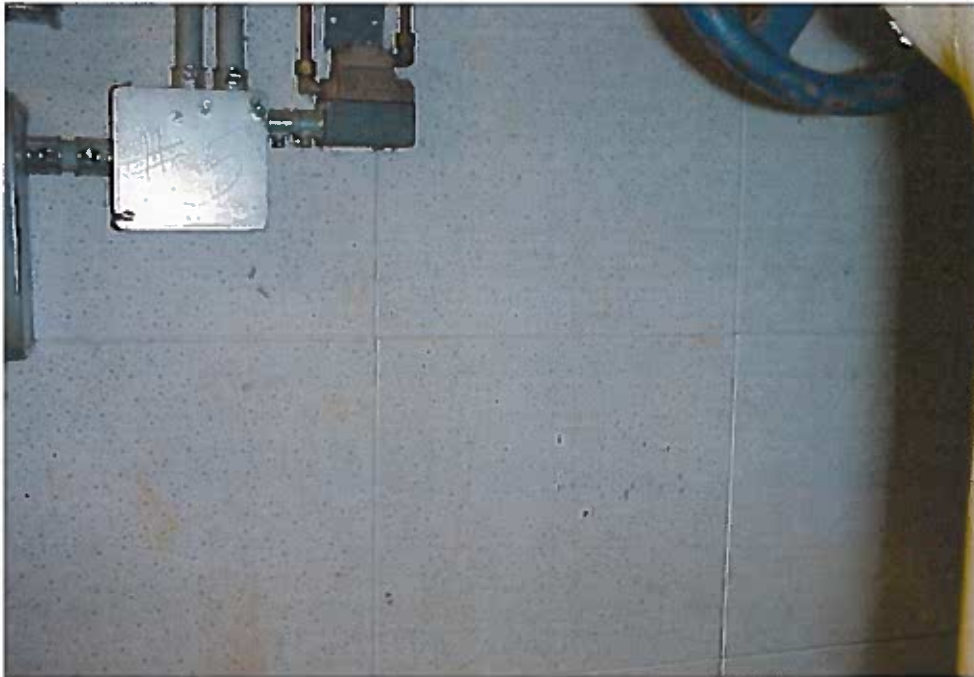
Wall Tile	2	-	189	-	Friable	Hazard Rank: 2
Homog. Area Description:	12"x12"Sq. wall tile, white, with random dot & mastic.					
Amount of Material:	~1800sf					
Homog. Area Definition:	This material can be found in mechanical rooms, ceiling in entrance to stairs going to the 3rd floor, & classrooms.					
Functional Space:	Public Area					
Sample Location:	Collected from south mechanical room, 3rd floor, 2-3-F.					
Primary Analysis Results:	<u>Chrysotile</u> 4%					
Secondary Analysis Results::	<u>No Asbestos Detect</u> 0%					
4% chrysotile found in second layer mastic.

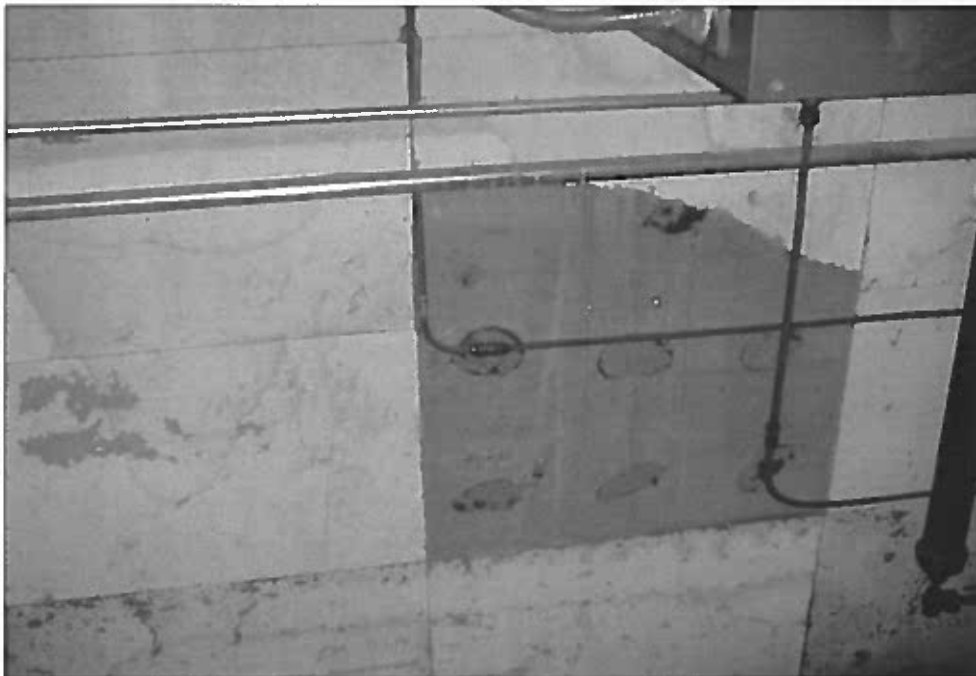
Wall Tile	3	-	281	-	Friable	Hazard Rank: 4
Homog. Area Description:	18"x24" Sq. wall tile, white with random dot, with mastic					
Amount of Material:	~1440sf					
Homog. Area Definition:	Material found Basement of mechanical room the walls.					
Functional Space:	Mechanical					
Sample Location:	Collected from wall #1.					
Primary Analysis Results:	<u>Chrysotile</u> 3%					
Secondary Analysis Results::	0%					
3% Chrysotile was discovered in the second layer mastic.

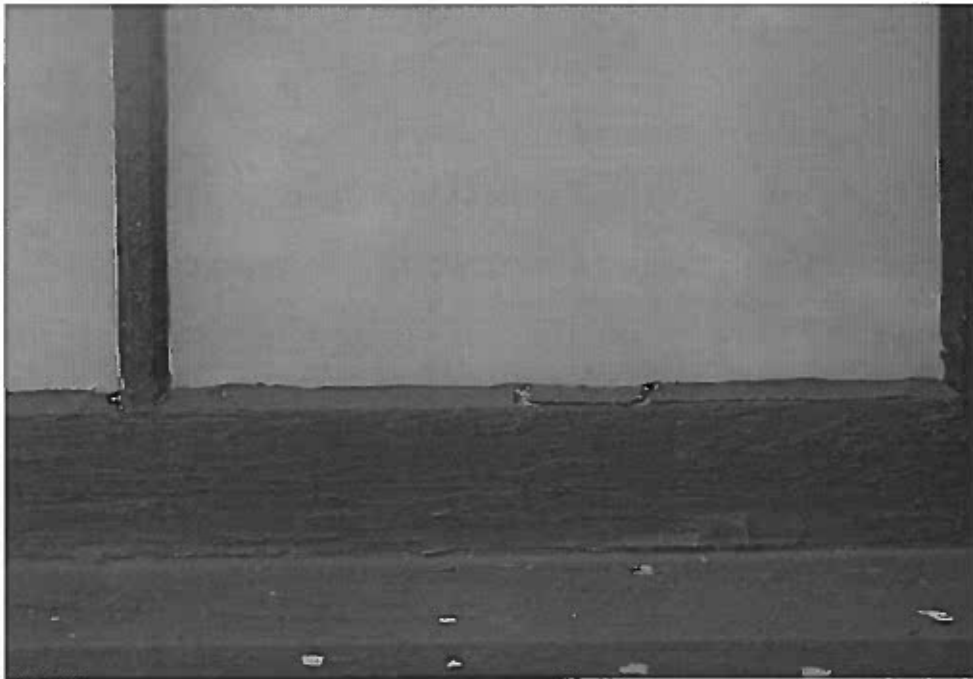
Window Glazing 1	- 307 -	Friable	Hazard Rank: 2
Homog. Area Description:	Window Glaze		
Amount of Material:	~140 windows		
Homog. Area Definition:	On all windows		
Functional Space:	Public Area		
Sample Location:	Collected from window at room #108		
Primary Analysis Results:	<u>Chrysotile</u>	2%	
Secondary Analysis Results::		0%

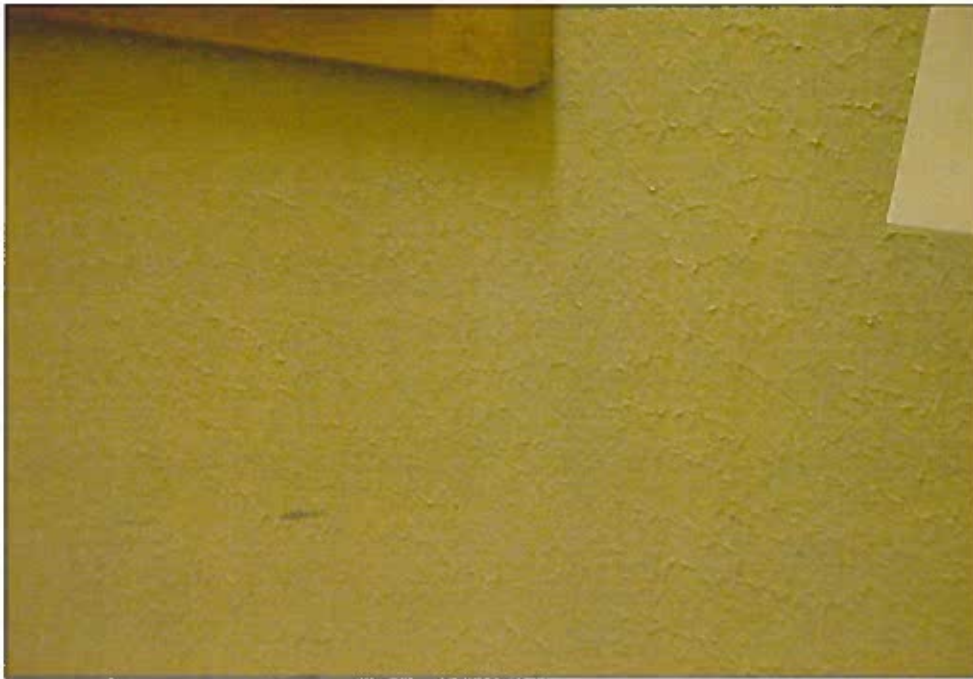
Texturizer	8	- 198 -	Non-Friable	Hazard Rank: 1
Homog. Area Description:	Yellow w/ waves and sheetrock.			
Amount of Material:	~660sf			
Homog. Area Definition:	The material can be found in room 208-C on the 2cd. Floor.			
Functional Space:	Public Area			
Sample Location:	Collected from room 208-C at wall 3 behind bookcase, 2-3-F.			
Primary Analysis Results:	<u>Chrysotile</u> 4%			
Secondary Analysis Results::	<u>No Asbestos Detect</u> 0%			
	White texture

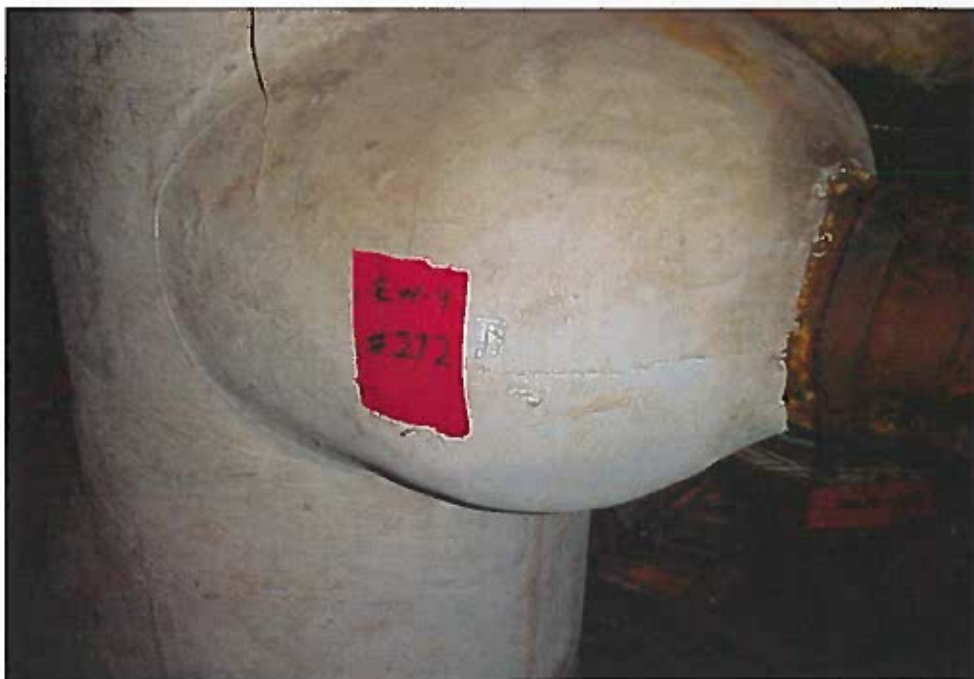
Elbow Wrap	4	-	273	-	Friable	Hazard Rank: 2
Homog. Area Description:	Pipe insulation elbows or fittings.					
Amount of Material:	~120elbows					
Homog. Area Definition:	This material is found in the mechanical rooms on the third floor, and the basement.					
Functional Space:	Mechanical					
Sample Location:	Collected from the basement mechanical room that is marked w/ red tape.					
Primary Analysis Results:	<u>Chrysotile</u>		2%			
Secondary Analysis Results::	<u>No Asbestos Detect</u>		0%			
Gray fibrous insulation.

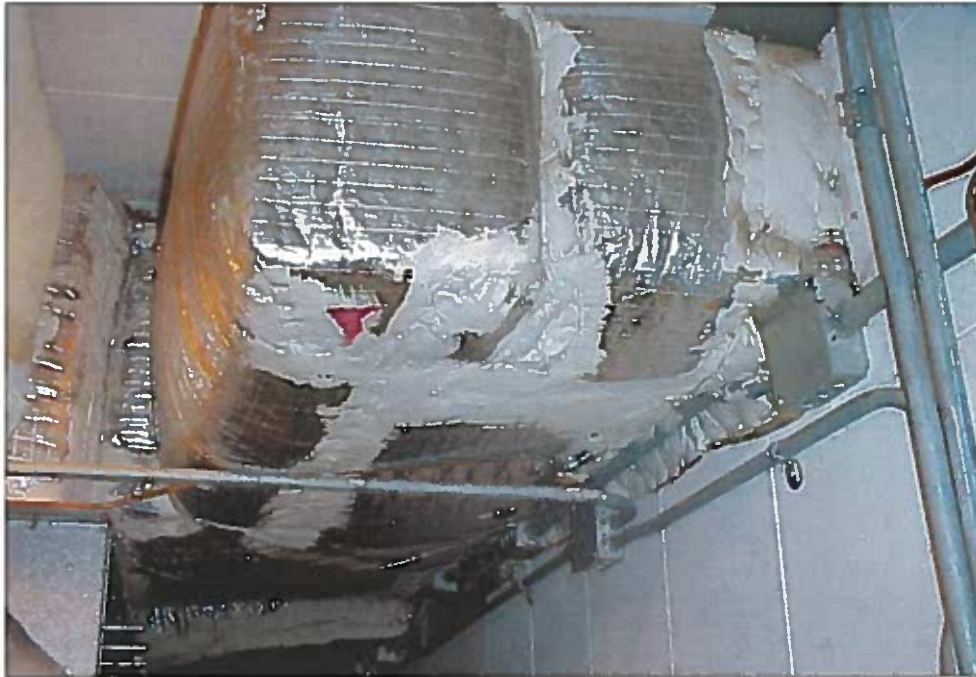
HVAC Insulation 3 - 183 - **Non-Friable** Hazard Rank: 2

Homog. Area Description: White mastic on AC ducts.
Amount of Material: ~19060 lb
Homog. Area Definition: This material can be found in mechanical rooms and above drop ceilings throughout building.
Functional Space: Mechanical
Sample Location: Collected from south mechanical room, 2-3-F, 3rd. Floor.
Primary Analysis Results: Chrysotile 7%
Secondary Analysis Results: 0%

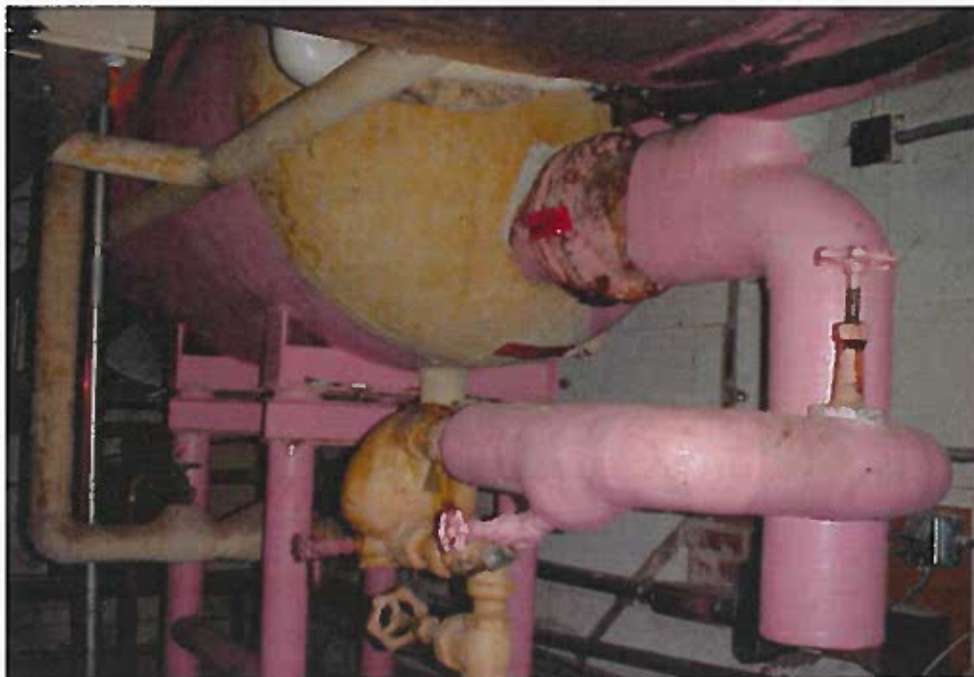
Tank Insulation 1	- 297 -	Friable	Hazard Rank: 4
Homog. Area Description:	Tank insulation		
Amount of Material:	~80sf		
Homog. Area Definition:	In the basement mechanical room		
Functional Space:	Mechanical		
Sample Location:	Collected from west end of the tank.		
Primary Analysis Results:	<u>Chrysotile</u>	62%	
Secondary Analysis Results::	<u>Chrysotile</u>	0%	
	Gray fibrous insulation and pink surfacing on canvas.

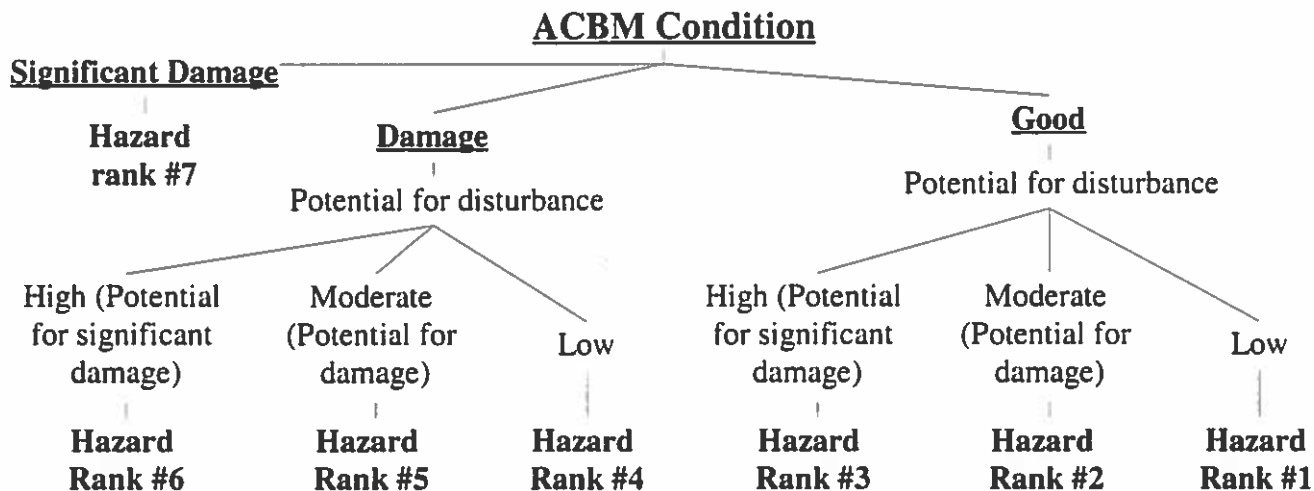
CLASSIFICATIONS FOR HAZARD POTENTIAL (DECISION TREE DISPLAY)

NOTE: AHERA does not account for combinations of current and potential damage (i.e. hazard ranks #5 and 6). The response actions shown are combinations of those required for each condition.
