**REQUEST FOR PROPOSAL
MIDWESTERN STATE UNIVERSITY
PURCHASING & CONTRACT MANAGEMENT DEPARTMENT
3410 Taft Blvd., Daniel Bldg., Rm. 202
Wichita Falls, TX. 76308**

735-16-8165

**Exterior Window Painting Hardin
Building**

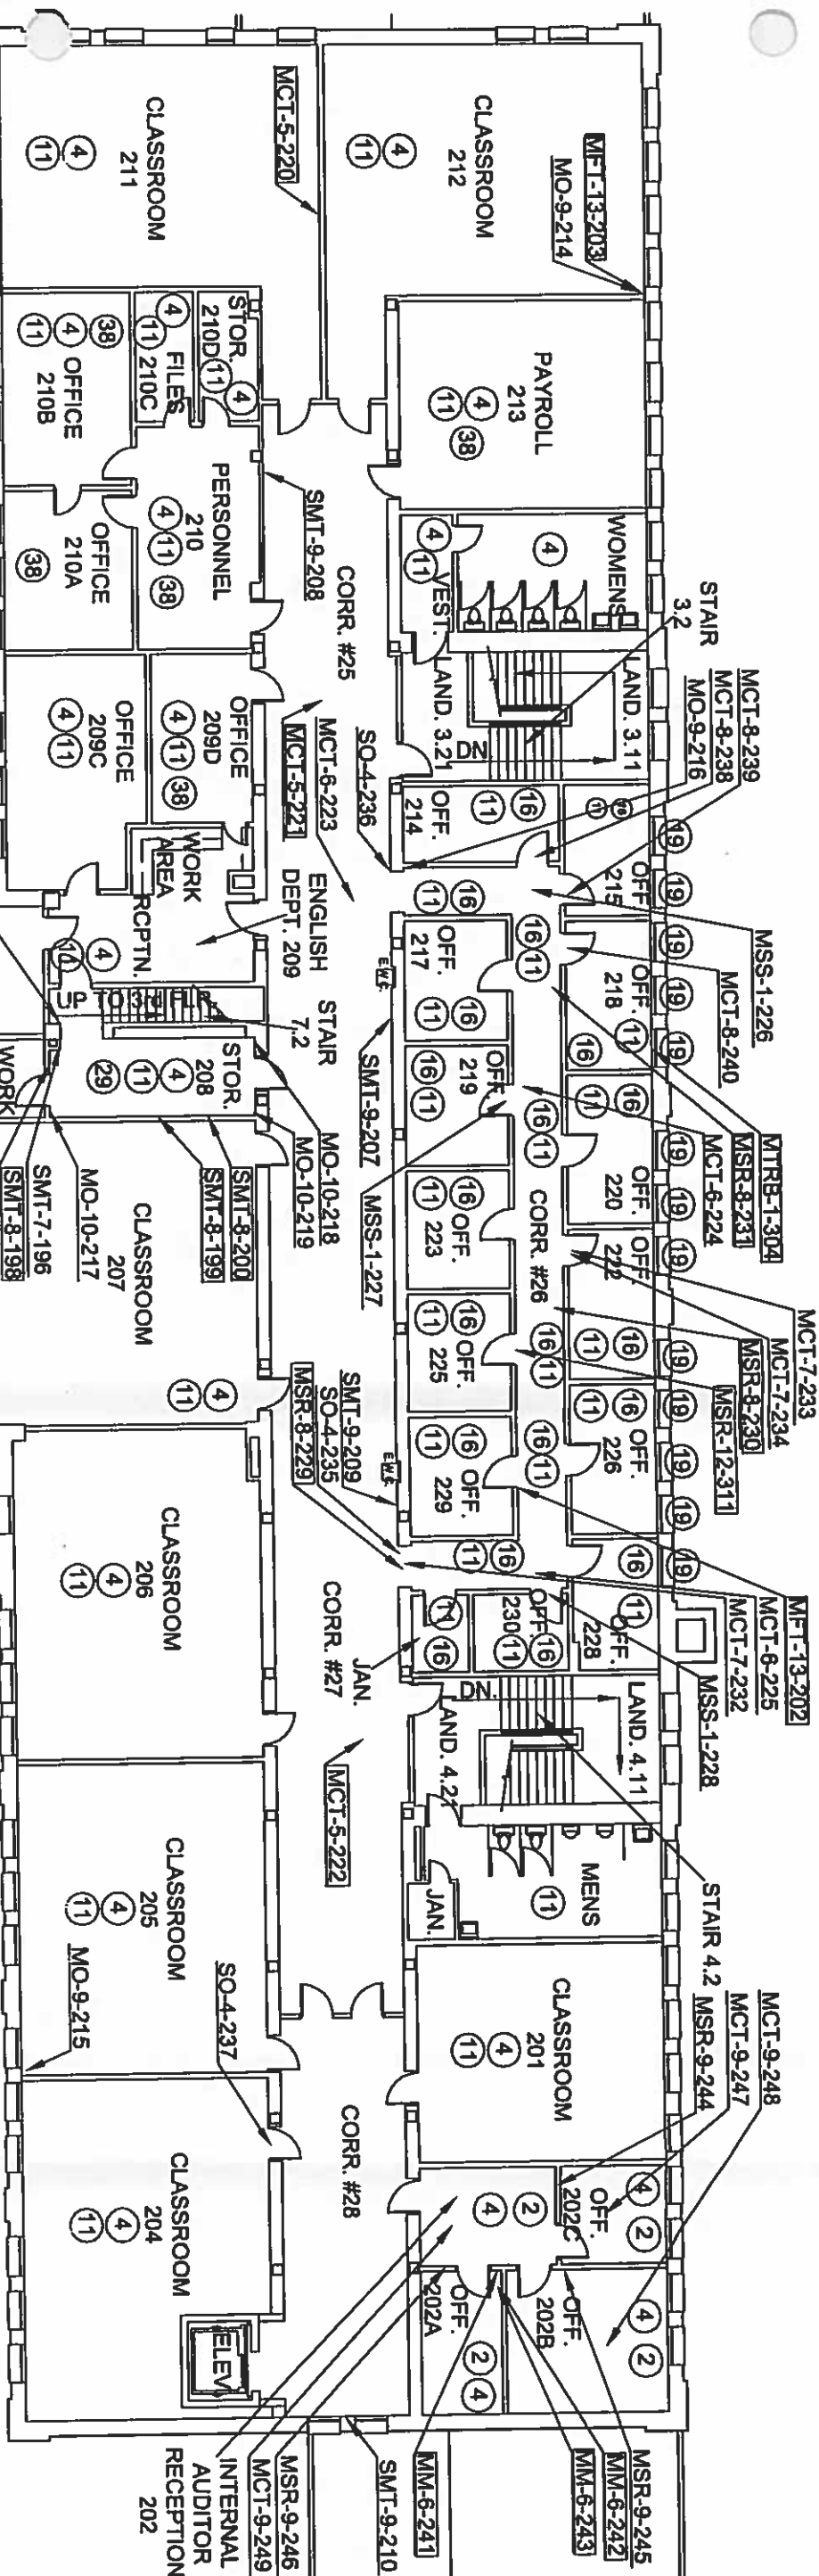
WICHITA FALLS, TEXAS

- INDICATES A SAMPLE THAT HAS REVEALED AN ASBESTOS CONTAINING SUBSTANCE
- REFER TO EESIS REPORT FOR VERIFICATION OF ALL LOCATIONS OF SAMPLES AND ASBESTOS CONTAINING SUBSTANCES.

SCALE: 1/16" = 1'-0"
